UNITED STATES DEPARTMENT OF AGRICULTURE, FOREST SERVICE

Starting Heavy Equipment During Cold Weather
By Wilfred S. Davis, Project Superintendent, Camp F-14,
Lightning Creek - Region 2

S H O P P R A C T I C E

T R A C T O R S

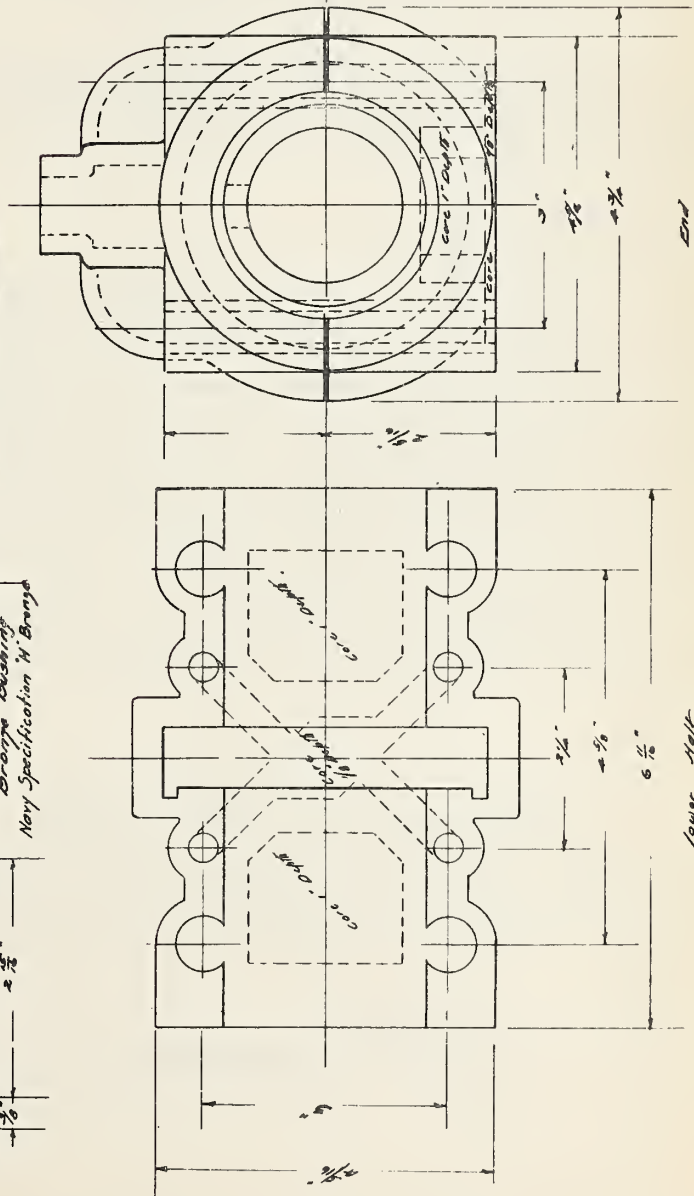
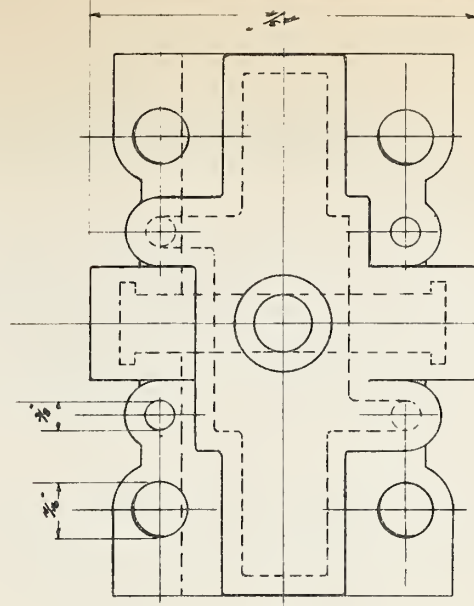
Top TQ-111

Cletrac "55" worn front wheel bearing assemblies are salvaged in the same manner as the lower wheel bearings.

The lower track wheel bearing on the Cletrac is not of the anti-friction type, and since the wearing surfaces are steel to cast-iron, and also, with the additional weight of the trailmaker, the more or less positive method of lubrication has caused a considerable amount of wear and repair on this bearing. The standard Cletrac bearing is made in two halves and is sometimes rather difficult to seal against oil leakage.

The two halves of the worn bearing were assembled and bored to 2-1/2 inches internal diameter. A bronze bushing of high tin content was then turned to fit the bearing, which was bored to 1-31/32 inches or 1/32 smaller than the standard Cletrac shaft, plus .010 for clearance. No dowels are used, since the distance between the bolt holes in the bearing is less than the outside diameter of the bushing. It is necessary to run a drill through the stud holes of the assembly - by so doing, a groove is cut in the bushing. (This prevents the movement of the bushing when the bearing is installed on the track frame studs.) Since the oil seal contacts a single bronze surface instead of the broken surface of the two halves, no difficulty has been experienced at this point. The shafts that are serviceable except for worn bearing surfaces are then ground between centers to 1/32 of an inch undersize, and installed in the bearing assembly.
